INVESTIGATION OF A FATAL FIRE IN A MOVING VEHICLE

ABSTRACT

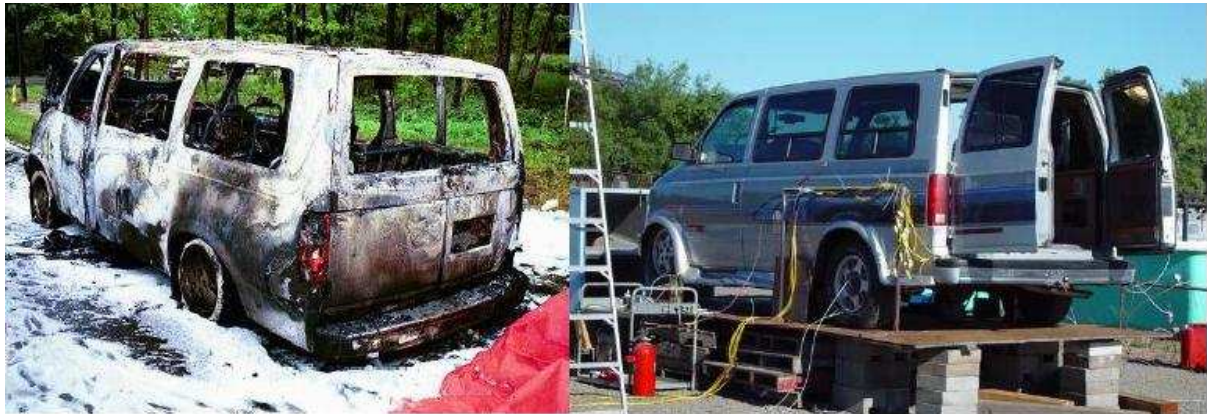
This paper presents the investigation conducted by the authors to test conflicting scenarios regarding the cause and origin of an accidental fire. This tragic fire (Fig. 1) occurred in a moving mini van, after 5 to 6 min of driving, and resulted in the death of three passengers, injuries to the surviving passenger and the driver and the complete loss of the vehicle. The initial fire investigators proposed that the fuel source was a fuel spray released from a degraded supply or return line next to exhaust components under the vehicle. Supposedly, the resultant flame exposed the rear floor pan of the vehicle to intense heat transfer resulting in the ignition of interior materials, and the subsequent fire burned out the vehicle interior. Allegedly, interior materials were ignited while the vehicle was traveling at moderate city

Figure 1. Vehicle testing site (right) and the post fire remains of the real case (left).

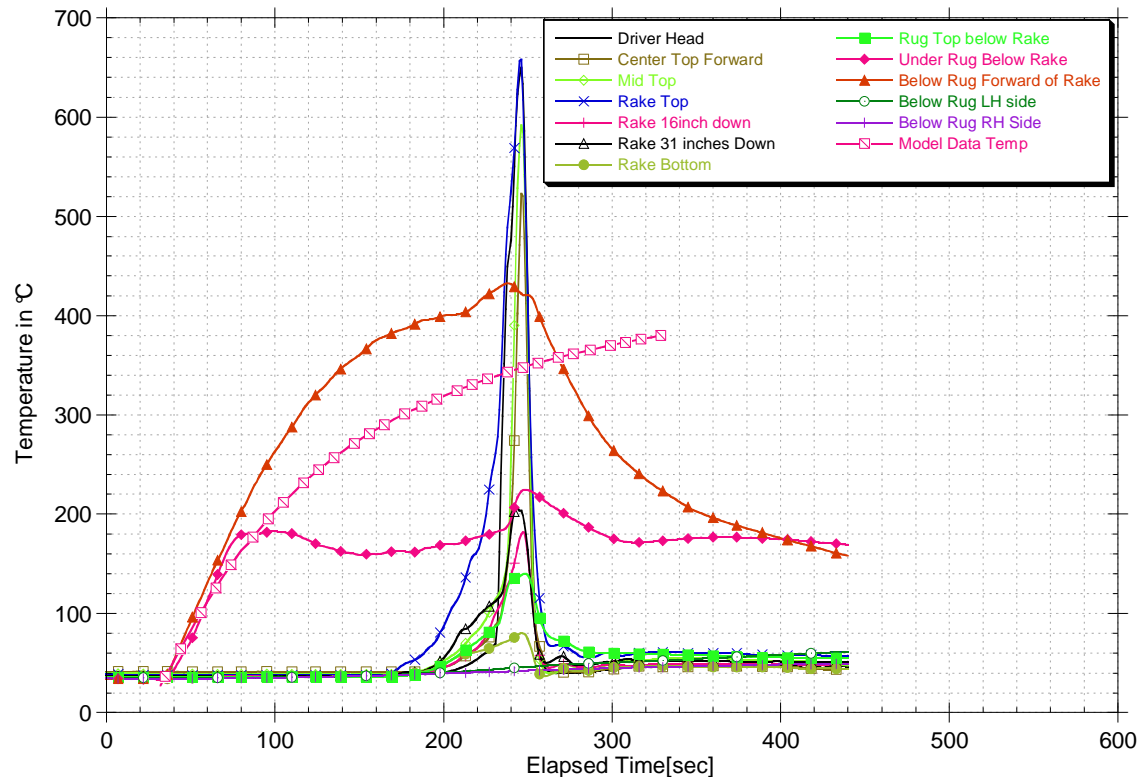
External Fire - Piloted ignition scenario: Fig. 5 shows the temperature measurements in the passenger compartment for the test where penetrations were present in the floor pan. At $t=0$, the spray-fire was initiated under the van and the temperature of the floor-covering material started to increase after 40 s. Piloted ignition occurred approximately after 210 s, and it is seen in Fig. 5 as the temperature of below the rake location reached 400 °C. Temperature rise at the ceiling thermocouples ('rake top') is first sensed at about 170 s after spray-fire initiation, and flames reached the height of the head liner at about 230 s when the fire was manually extinguished. Video records showed visual evidence of smoke at the back of the van approximately 120 s after spray-fire initiation and 80 s before fire reached the headliner in the test with floor pan penetrations. Both acetaldehyde and acrolein were detected inside the compartment before the tests was terminated. Comparison with the results from the ignition model of Eqs. (1) and (2) shows good agreement. Translating the time zero of the heat transfer model results to the first measured temperature increase ($t=40$ s). When flames penetrate the compartment at 210 s, the model predicted temperatures of 350°C, which compares well with the 400°C measured below the rake. The affected carpet material was replaced after this experiment to allow the next large-scale experiment.

Figure 5. Under-floor spray test: penetrations at flame impingement site.
Temperature measurements and heat transfer modeling results.

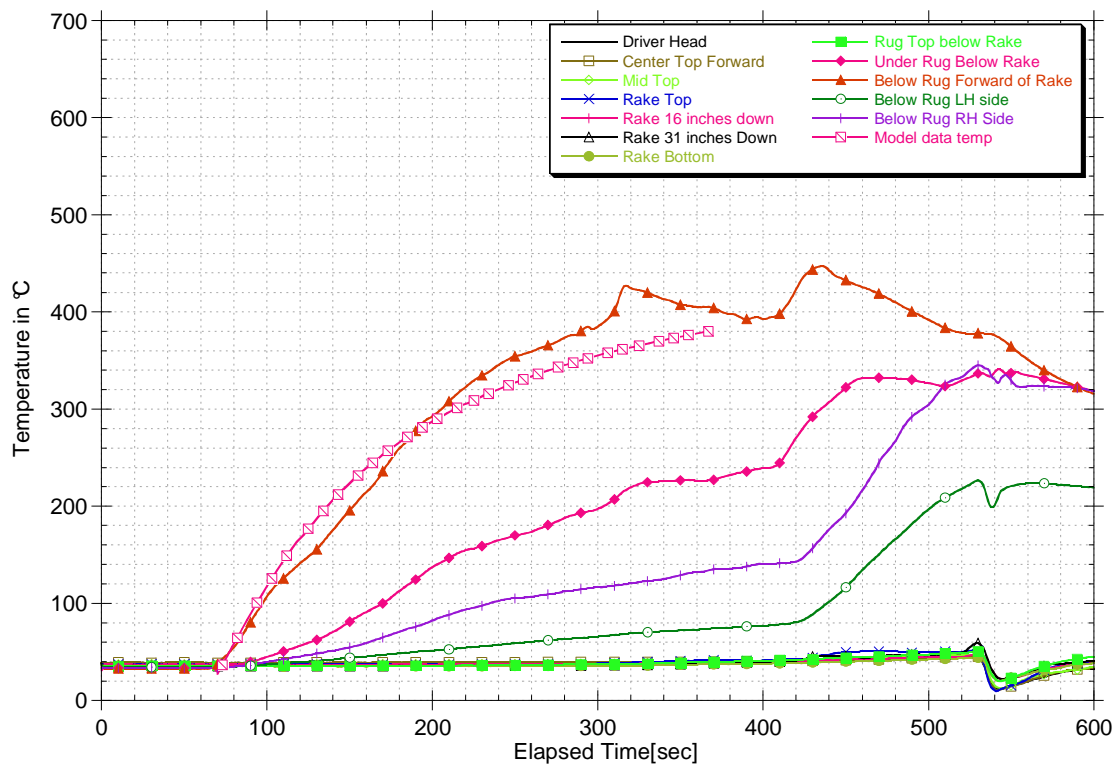
External Fire - Auto ignition scenario: Fig. 6 shows the temperature measurements in the compartment for the test where there were no penetrations in the floor pan. Significant heating of the steel floor is starts at 70 s and the subsequent rise is very similar to that in the previous test since the outside spray-fire and air flow conditions were the same. However, there is no fire ignition in the compartment in more than 500 s. Smoke was visible at 230 s at the back of the van for the test where there were no floor pan penetrations – filling the van and becoming progressively denser until the test was terminated. Thermocouples inside the compartment show essentially no temperature rise. The heating of the floor caused extensive thermal degradation of the floor-covering materials in a radius of about 0.5 m around the flame impingement point but were not high enough to cause spontaneous ignition. This time line correlates well with camera recordings of the experiment. Both acetaldehyde and acrolein were detected inside the compartment before the tests was terminated. In order to test the effect of the external airflow, at 300 s the air fan was shut down. Thus, external convective heat-losses were substantially reduced and the effect in the steel floor is immediate, showing at sudden rise of 40°C at 300 s (see thermocouple 'below rake forward' in Fig. 6). For this experiment both acetaldehyde and acrolein were also detected inside the compartment before the tests was terminated.

Comparison with the results from the ignition model of Eqs. (1) and (2) shows very good agreement. It is seen the heating curves are the same and predictions are within the expected experimental error range (± 5 %). The comparison in this test is even better than for the previous one because the model assumptions do not contemplate the effect of the penetrations in the floor-pan.

Figure 6. Under floor spray test: no penetration at flame impingement site.
Temperature records and heat transfer modeling results.
